SITE NUMBER: CW-L1-01
LOCAL NAME: Unnamed Trib
WRIA:

NORTH COAST OFF CHANNEL SITE INVENTORY DATA

RIVER SYSTEM: Clearwater **DATE:** 4/14/88 **OBSERVER:** Nettnin

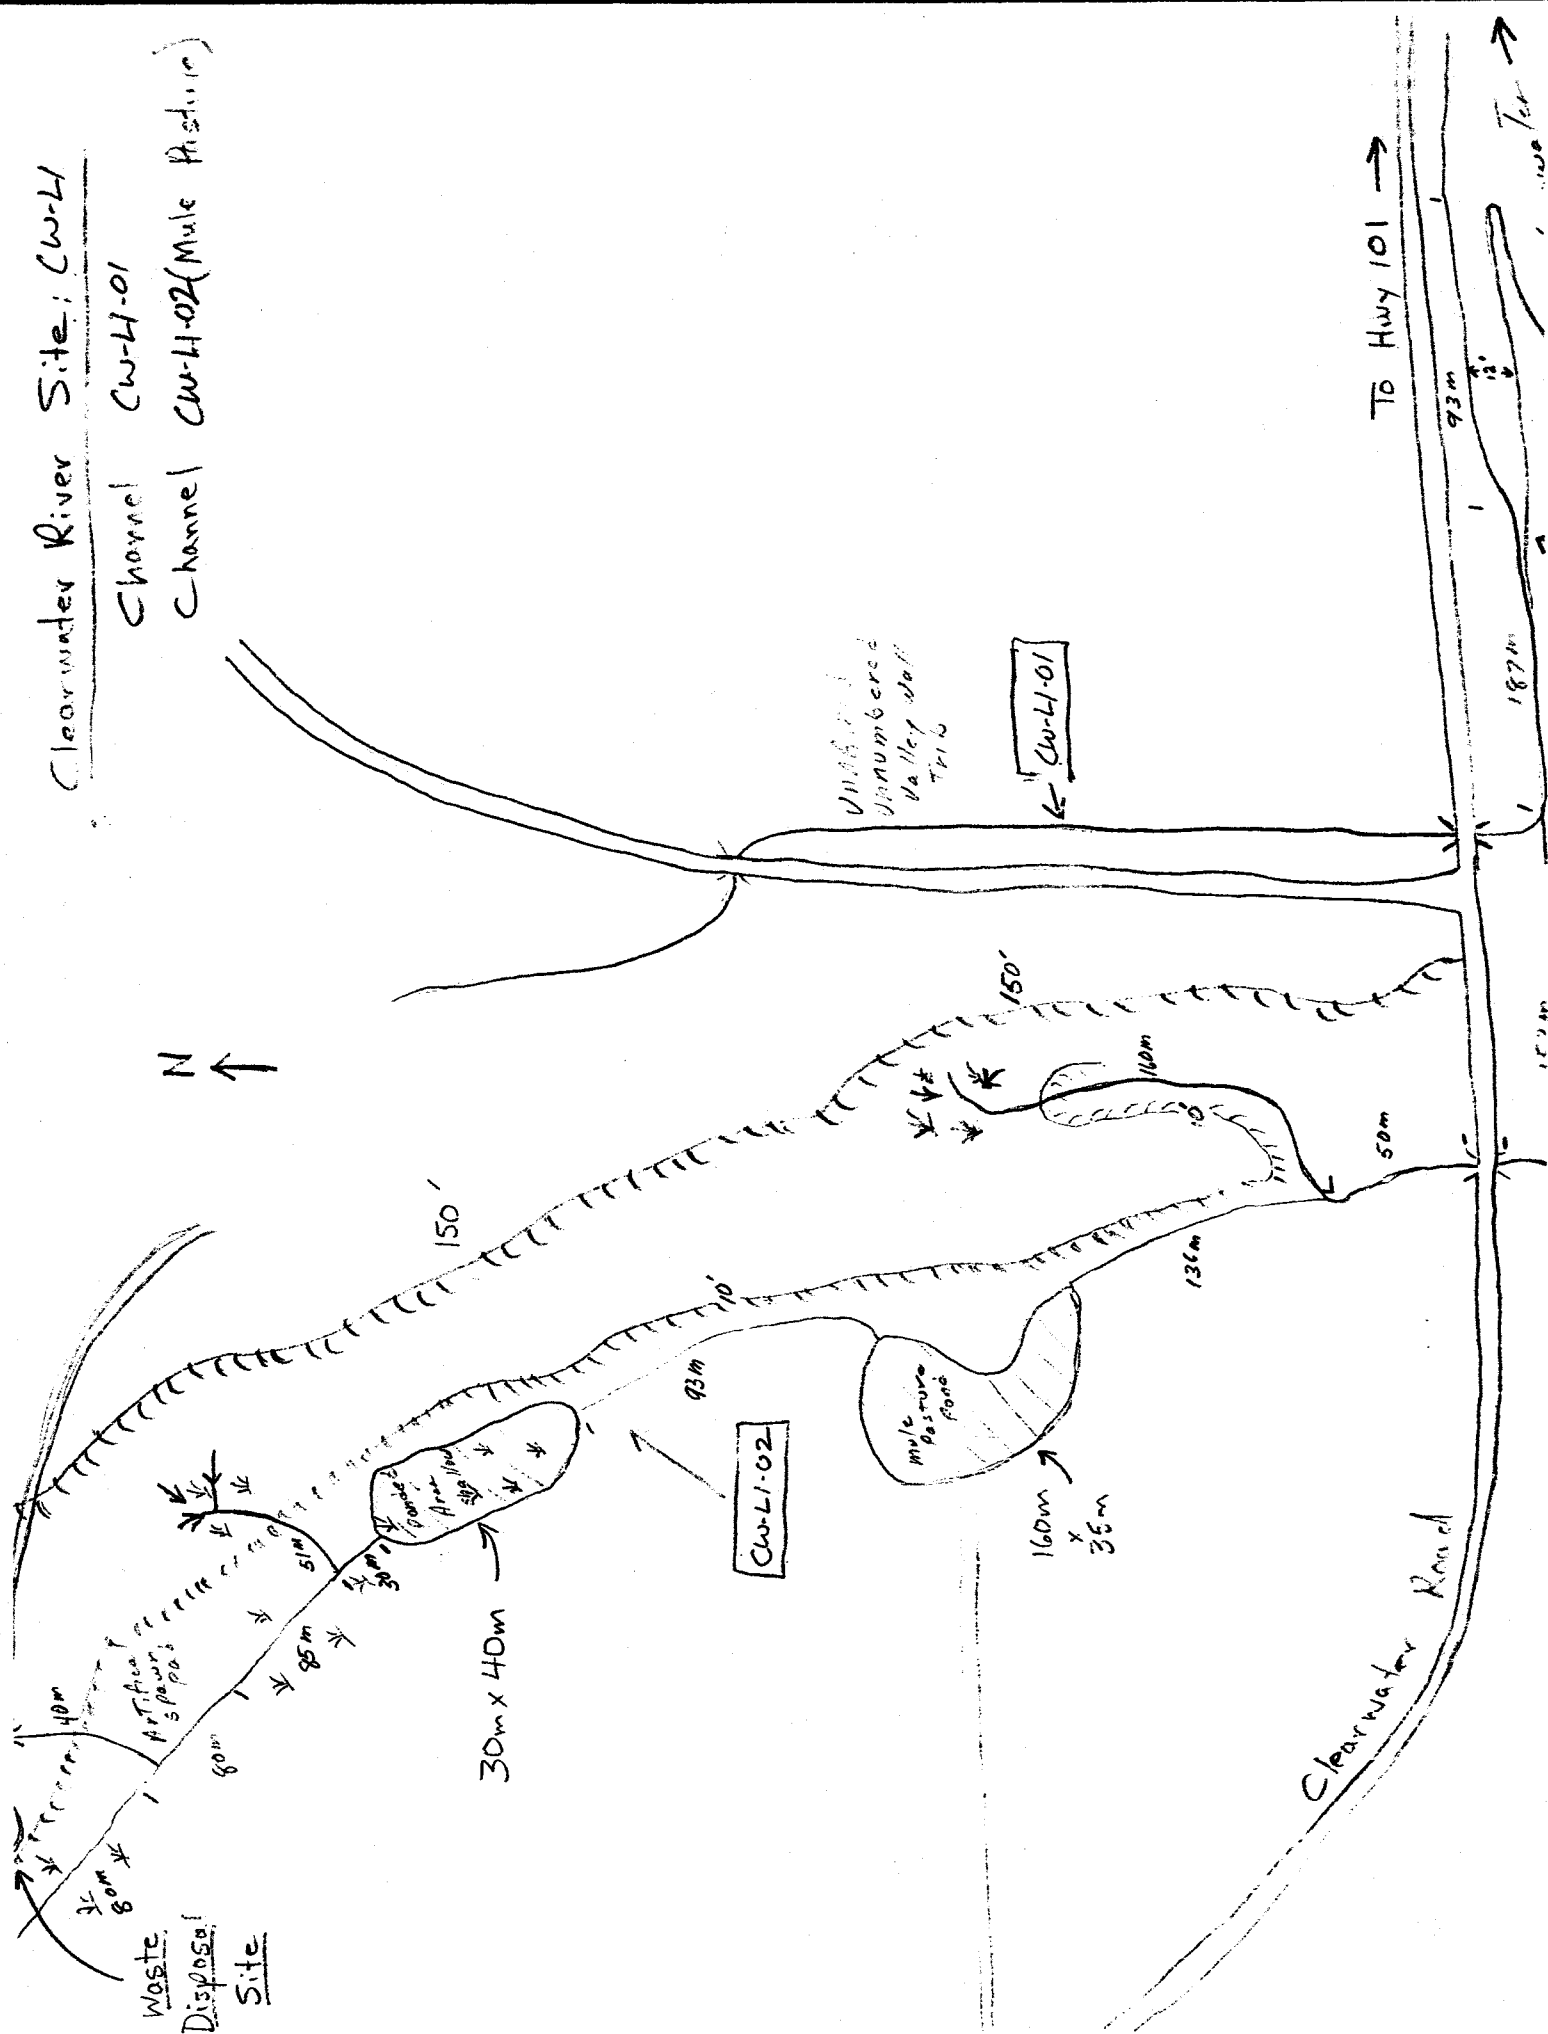
Channel CW-11-02 (Mule District)

COMMENTS & RECOMMENDATIONS: The low gradient section of this valley wall trib (below Clearwater Rd. offers some rearing area. It also provides access to the excellent rearing area in terrace trib CW-L1-02 (Mule Pasture Pond). CW-L1-02 enters CW-L1-01 just downstream from the Clearwater Rd. culvert.

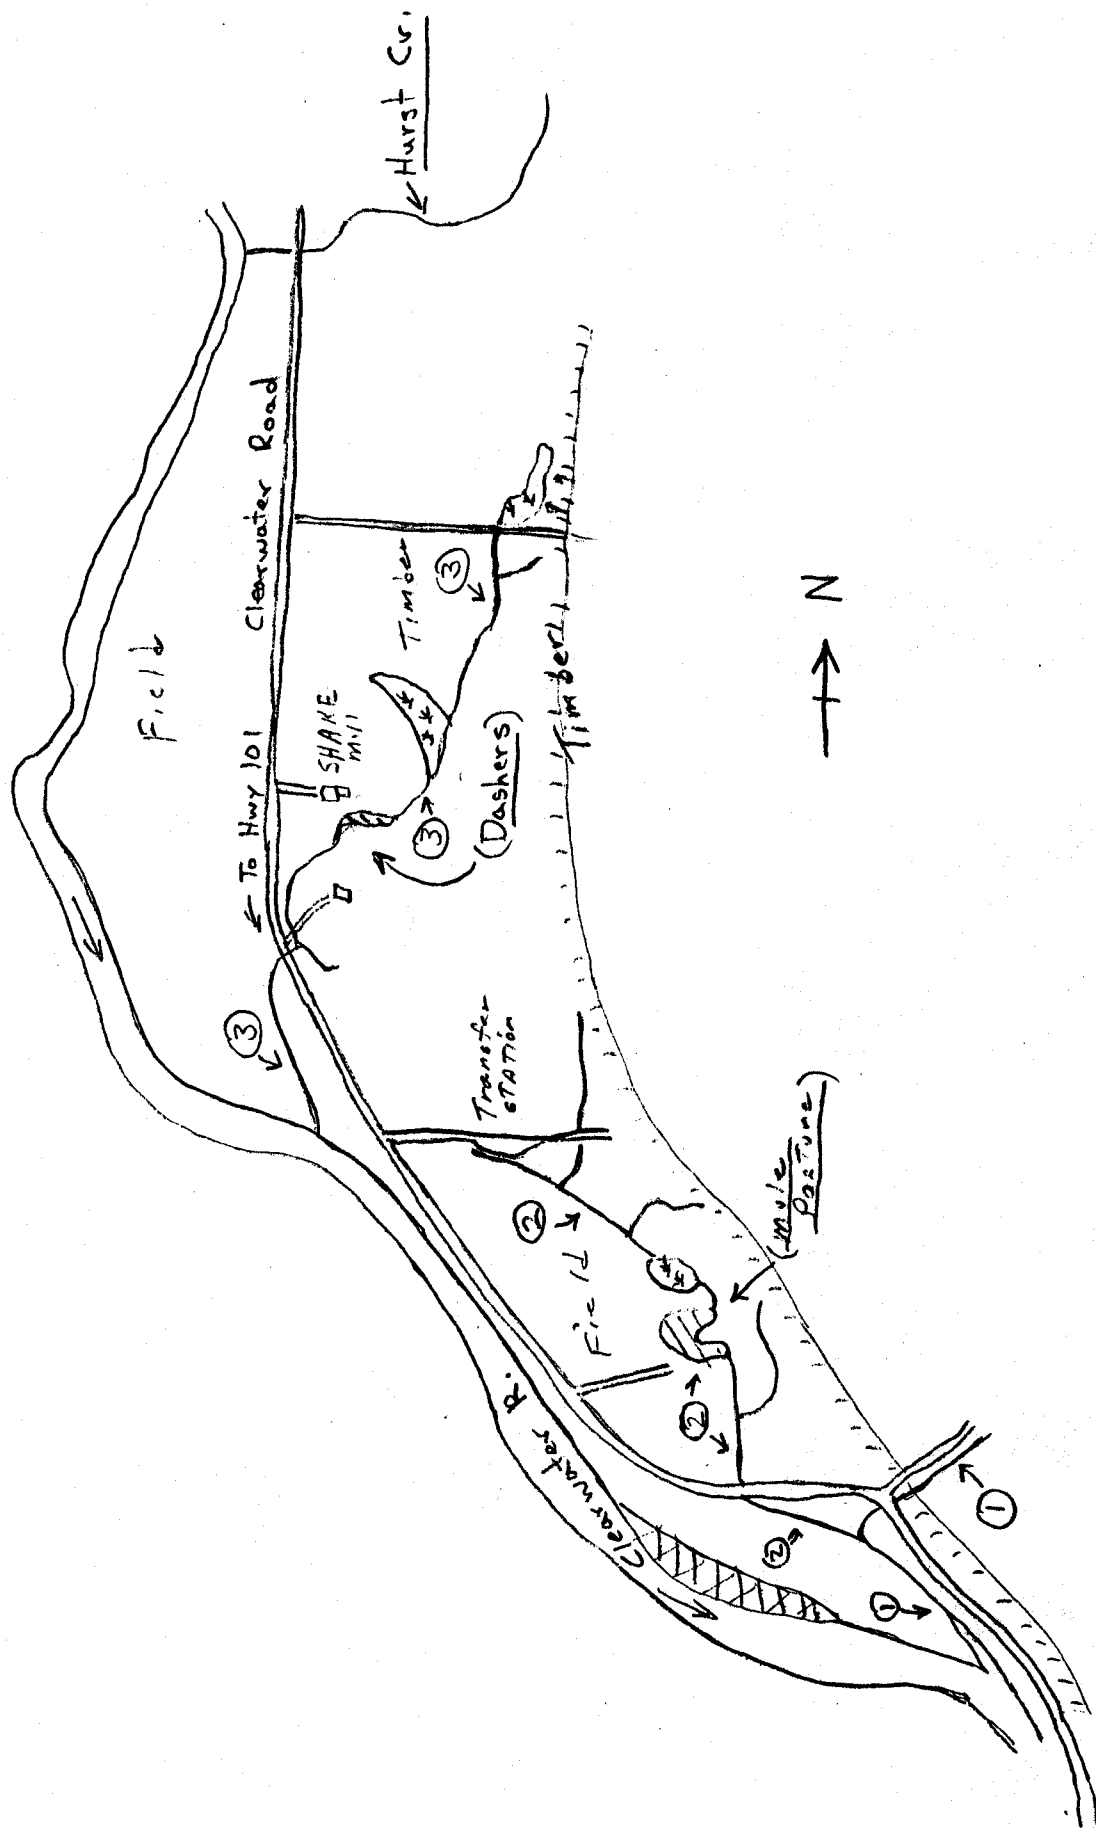
Clearwater River Site: CW-41

Overview Map
